**SITE ASSESSMENT REPORT
FOR
FORMULATED PRODUCTS
CLYDE, SANDUSKY COUNTY, OHIO
TDD: T05-9403-012
PAN: EOH1026SAA
DOCUMENT CONTROL NUMBER: TAT-05-23-04009**

MAY 11, 1994

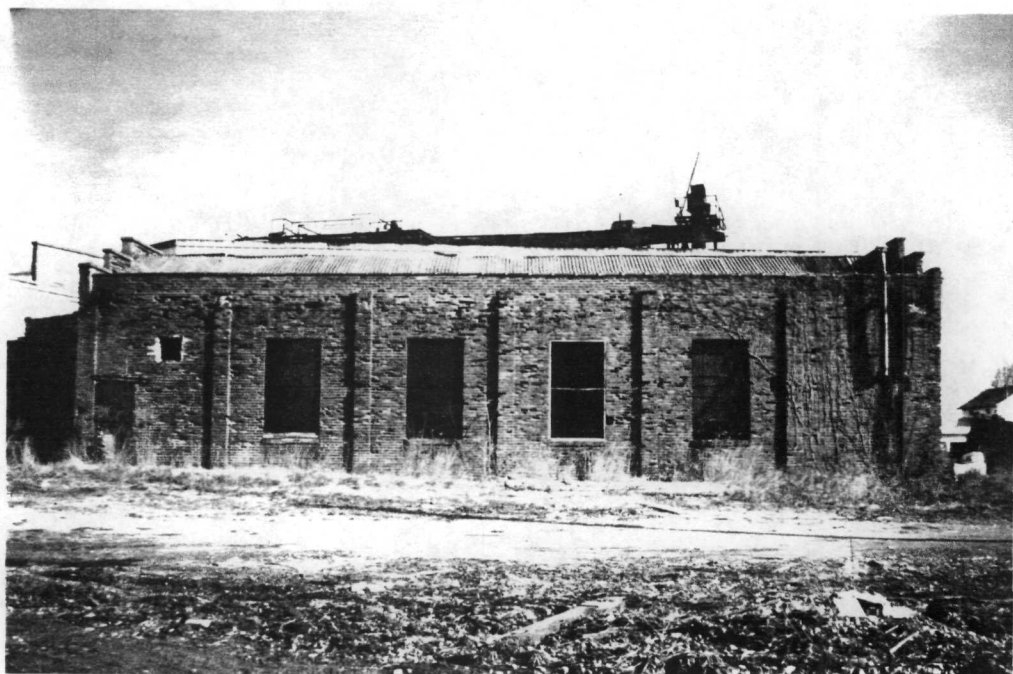
SITE NAME: FORMULATED PRODUCTS **TDD:** T059403012 **PAN:** EOH1026SAA
DIRECTION: NORTH **DATE:** 03/31/94 **PHOTOGRAPHER:** SW
DESCRIPTION: STORAGE GARAGE ON SOUTH SIDE OF THE FACILITY, EAST END OF THE BUILDING.

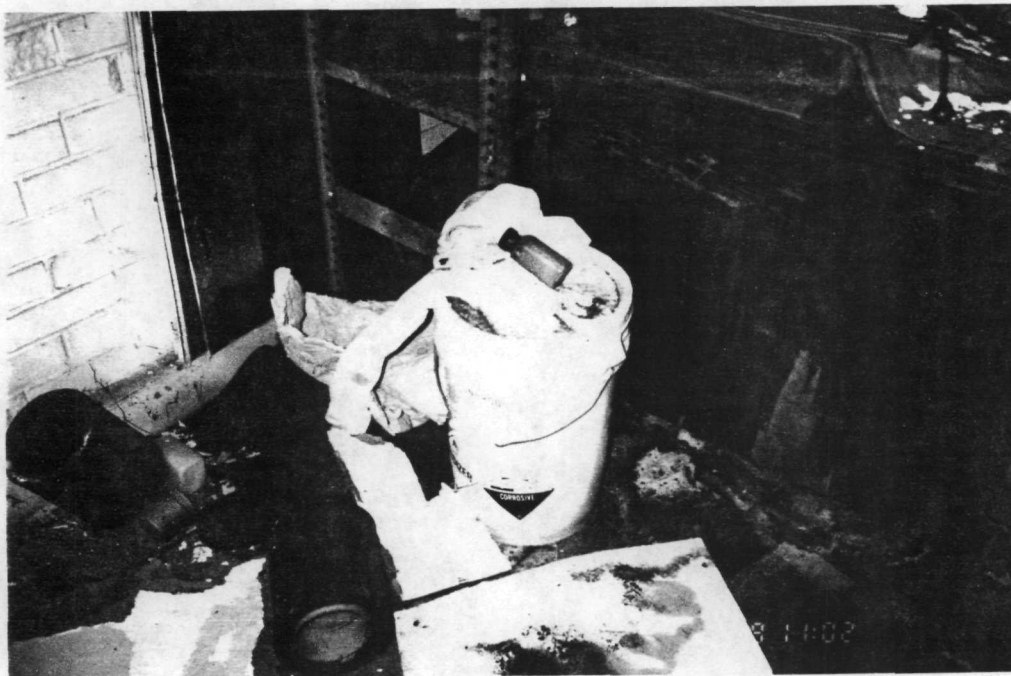
SITE NAME: FORMULATED PRODUCTS **TDD:** T059403012 **PAN:** EOH1026SAA
DIRECTION: NORTHWEST **DATE:** 03/31/94 **PHOTOGRAPHER:** FD
DESCRIPTION: 5-GALLON CONTAINER OF CORROSIVE, OXIDIZING SOLID IN
LABORATORY.

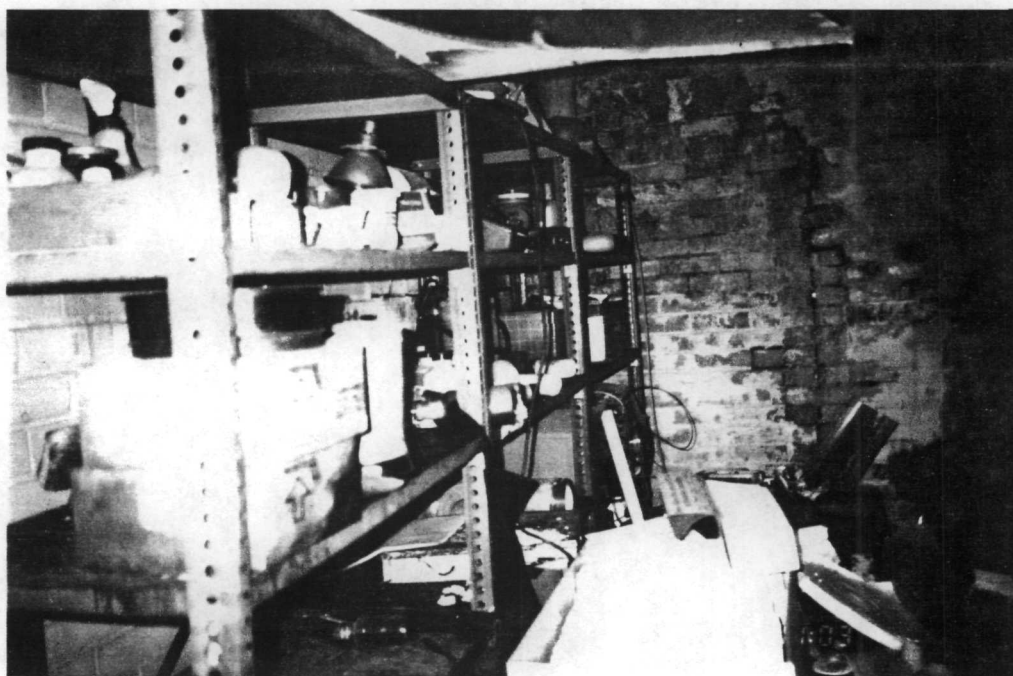
SITE NAME: FORMULATED PRODUCTS **TDD:** T059403012 **PAN:** EOH1026SAA
DIRECTION: NORTH **DATE:** 03/31/94 **PHOTOGRAPHER:** FD
DESCRIPTION: SHELVES OF CHEMICALS IN LABORATORY, BUILDING B5.

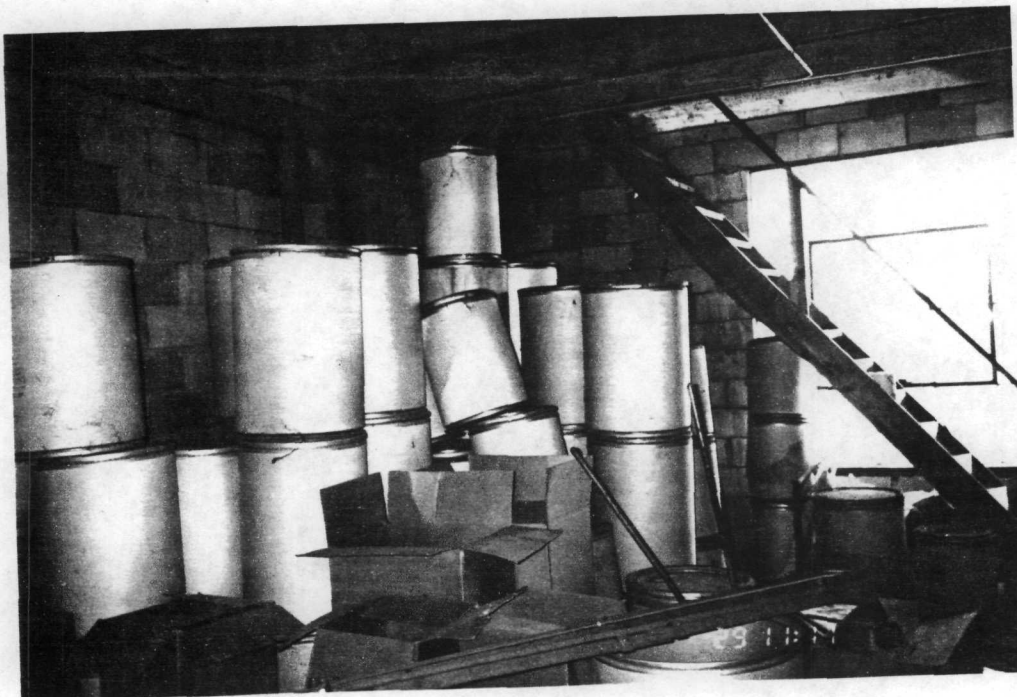
SITE NAME: FORMULATED PRODUCTS **TDD:** T059403012 **PAN:** EOH1026SAA
DIRECTION: WEST **DATE:** 03/31/94 **PHOTOGRAPHER:** FD
DESCRIPTION: SECOND FLOOR OF BUILDING B5. EMPTY FIBER DRUMS REST ON DETERIORATING FLOOR ABOVE LABORATORY ROOMS.

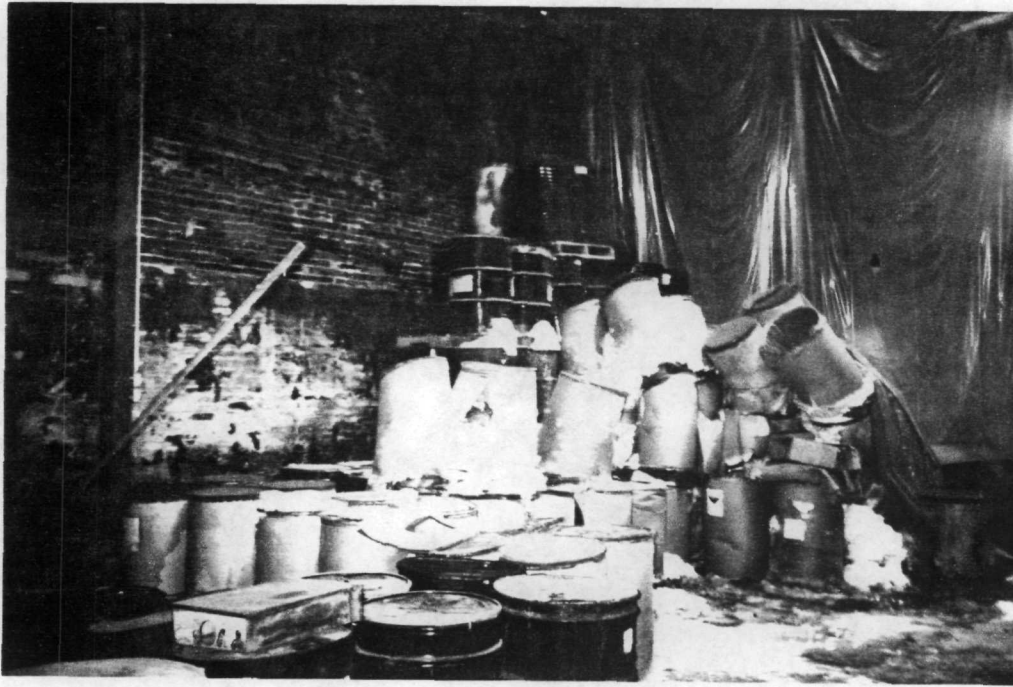
Many of drums labeled as caustic soda are either in a severely deteriorated state, or they have broken open and spilled their contents onto surrounding drums or flooring. Much of the spilled contents shows evidence of varying degrees of reactivity with moisture; probably rainfall which has entered storage areas through broken windows and/or openings in the building ceilings. Areas of discoloration on concrete floors and large puddles of yellow colored liquid around clusters of deteriorated drums suggest that either liquid contents have leaked from the drums or that solid contents have mixed with water and flowed away from the drums.

SITE NAME: FORMULATED PRODUCTS **TDD:** T059403012 **PAN:** EOH1026SAA
DIRECTION: NORTHEAST **DATE:** 03/31/94 **PHOTOGRAPHER:** FD
DESCRIPTION: STOCKPILE OF FIBER AND STEEL 55-GALLON DRUMS CONTAINING CAUSTIC SODA. DRUMS WERE SEVERELY DETERIORATED DUE TO EXPOSURE TO MOISTURE, AND CONTENTS WERE SPILLED ON THE FLOOR.

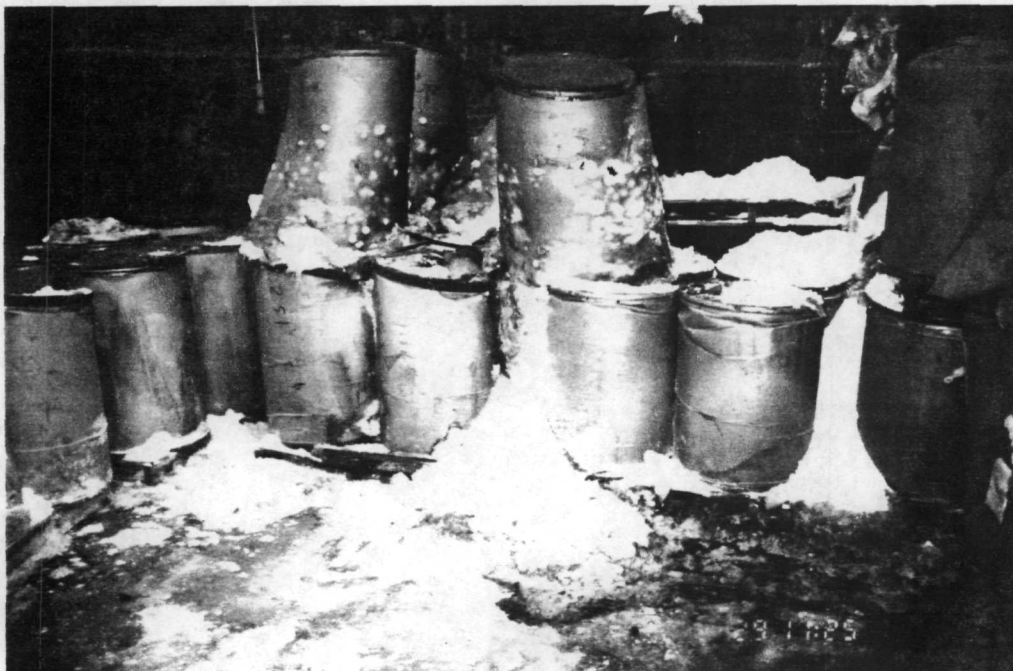
SITE NAME: FORMULATED PRODUCTS **TDD:** T059403012 **PAN:** EOH1026SAA
DIRECTION: NORTHWEST **DATE:** 03/31/94 **PHOTOGRAPHER:** FD
DESCRIPTION: CLOSE UP VIEW OF DETERIORATED DRUMS CONTAINING CAUSTIC SODA. DISCOLORED AREAS ON THE FLOOR RESULTED FROM EXPOSURE TO WATER.

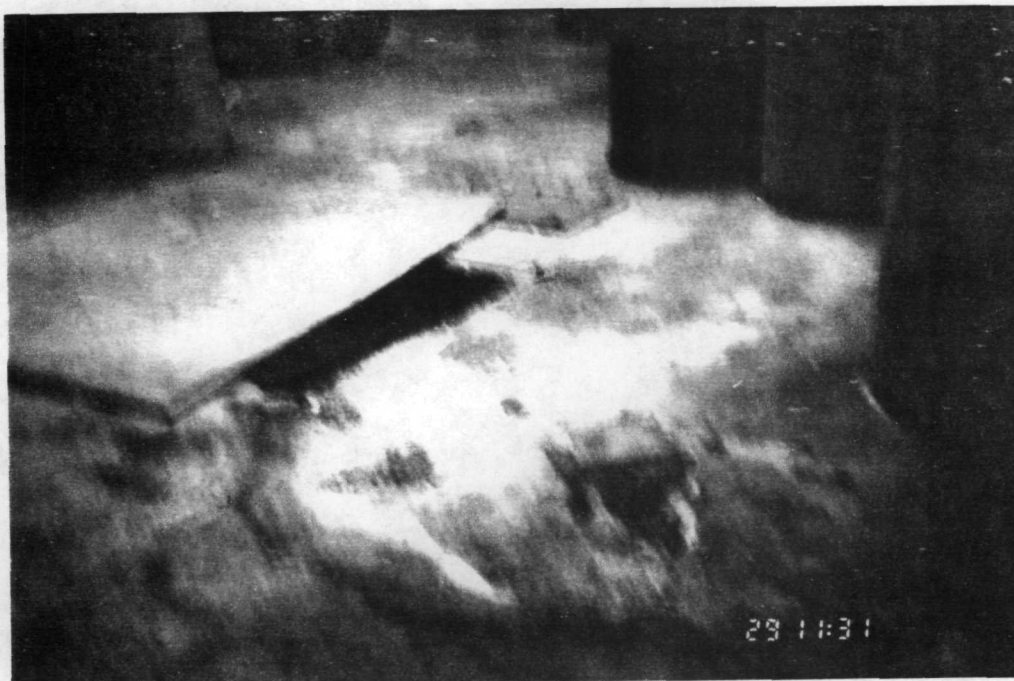
SITE NAME: FORMULATED PRODUCTS **TDD:** T059403012 **PAN:** EOH1026SAA
DIRECTION: SOUTHEAST **DATE:** 03/31/94 **PHOTOGRAPHER:** FD
DESCRIPTION: PIT NEAR VAT IN THE NORTHEAST END OF THE BUILDING 3.
 CONTENTS OF PIT WERE BLUE-GREEN COLORED.

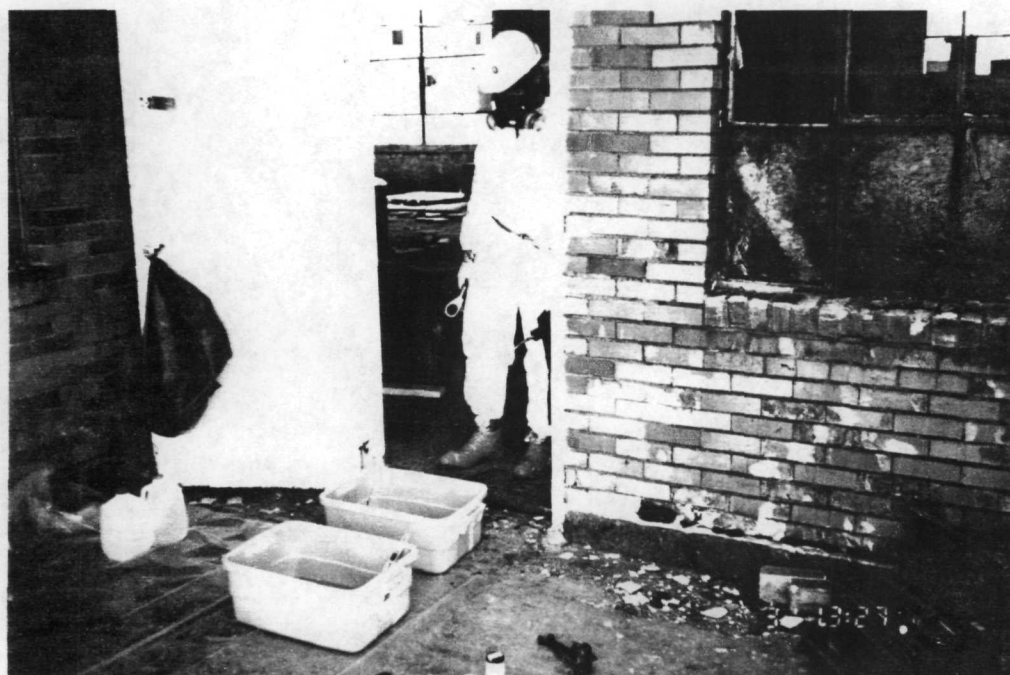
SITE NAME: FORMULATED PRODUCTS **TDD:** T059403012 **PAN:** EOH1026SAA
DIRECTION: SOUTH **DATE:** 03/31/94 **PHOTOGRAPHER:** FD
DESCRIPTION: TAT MEMBER PREPARES TO EXIT THE FACILITY. PLASTIC TUBS
 CONTAINING DECONTAMINATION SOLUTION WERE PART OF THE DECON ZONE SET UP
 OUTSIDE THE BUILDING AT THE EXIT POINT.

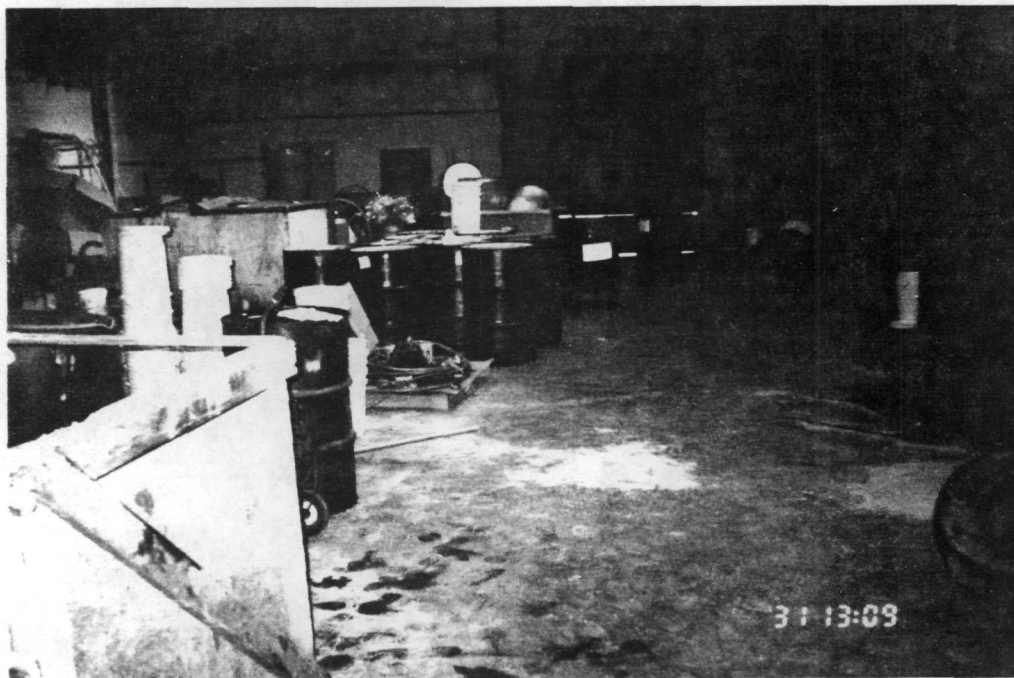
SITE NAME: FORMULATED PRODUCTS **TDD:** T059403012 **PAN:** EOH1026SAA
DIRECTION: EAST **DATE:** 03/31/94 **PHOTOGRAPHER:** FD
DESCRIPTION: ANOTHER VIEW OF PAILS, STEEL AND FIBER DRUMS, EQUIPMENT AND
 DEBRIS ABANDONED AT THE FACILITY.

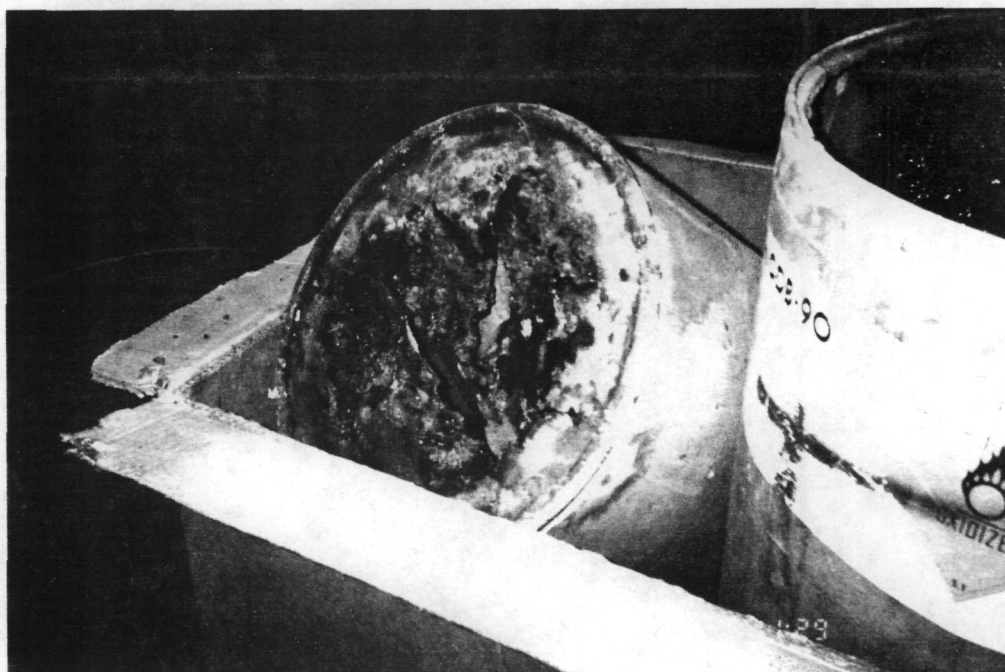
SITE NAME: FORMULATED PRODUCTS **TDD:** T059403012 **PAN:** EOH1026SAA
DIRECTION: N/A **DATE:** 03/31/94 **PHOTOGRAPHER:** FD
DESCRIPTION: SEVERELY CORRODED BOTTOM OF A FIBER DRUM THAT CONTAINED AN
 OXIDIZER.
